TP 185E
Issue 1/2013

AVIATION SAFETY LETTER

Featured Accident Report: Alone Across the Pond...

Recently Released TSB Reports

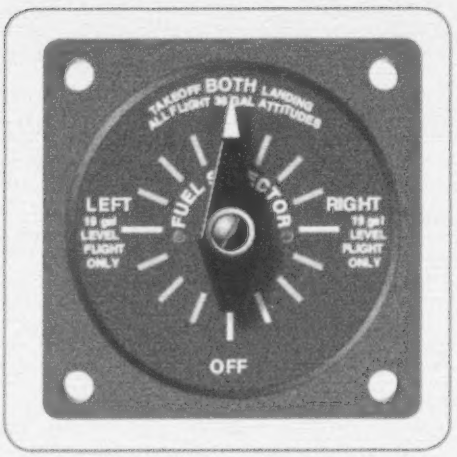
The fuel valve on that C172 was different than the fuel valve I was used to in the C152. The rotary type of valve on the C172 could be selected to left tank only, right tank only, both tanks, or off. The C152 fuel valve I was accustomed to had only two options: on or off.

There is no ON position on this valve; only BOTH, RIGHT, OFF, and LEFT.

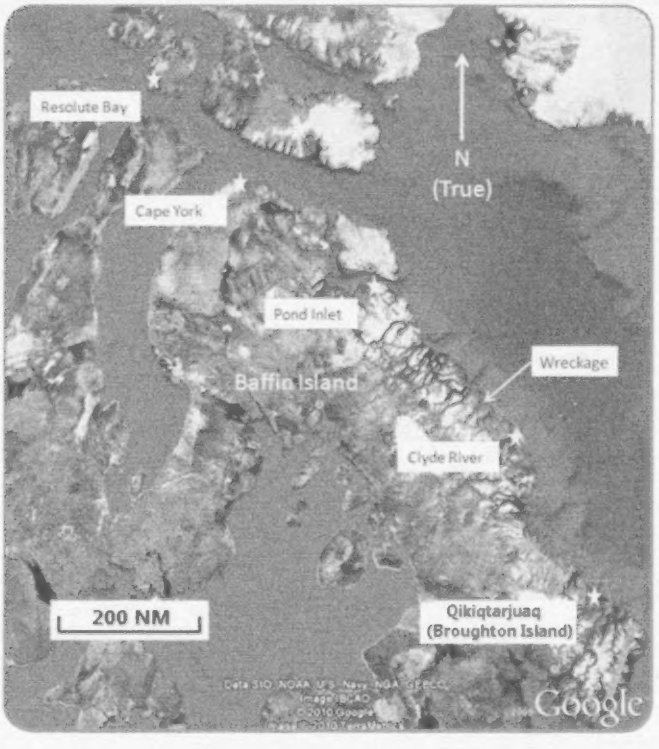
Route map

On August 16, 2010, a Bell 206L helicopter departed Clyde River, Nunavut, at 1609 Eastern Daylight Time on a VFR flight to Pond Inlet, Nunavut. Reduced visibility and low ceilings were forecast along the eastern coast of Baffin Island. The aircraft was equipped with a flight following device and was reported overdue at 1819. A search was initiated in the area of the last known position and wreckage was recovered from the surface of the sea on August 17, approximately 40 NM northwest of Clyde River. The helicopter was destroyed by impact forces; there was no fire. The pilot, the sole occupant of the helicopter, was not found. The accident occurred during daylight hours. No emergency locator transmitter (ELT) signal was detected by the SAR system.

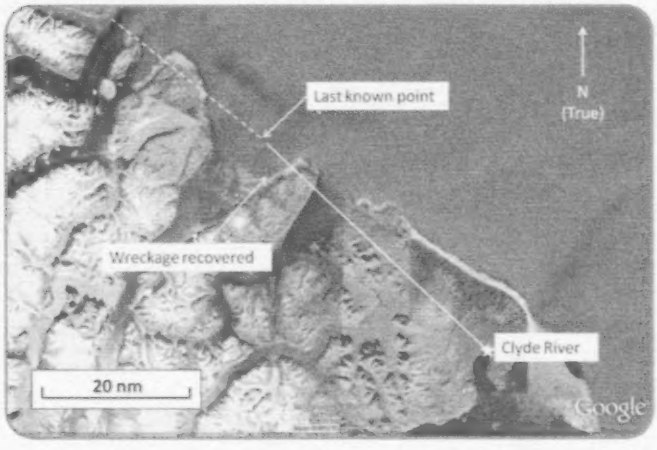
Last route segment

The helicopter was crossing the mouth of a 15 NM-wide fjord when it went missing. The last known position was approximately one-third of the way across. It is unlikely the pilot would attempt the crossing if the far side was not visible. This would imply the visibility must have improved in the area of the fjord, at least when the crossing was initiated.

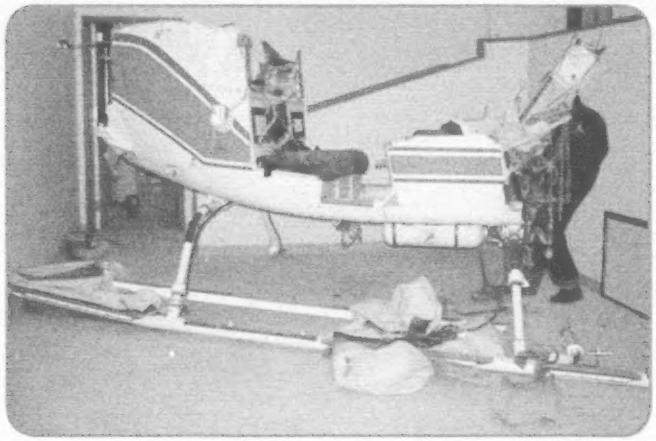
Recovered fuselage

The engine, most of the cockpit, and most of the tail section were not recovered. The fracture surfaces observed on the recovered sections were attributed to overstress as a result of water impact. The degree of helicopter break-up and damage to the recovered sections indicate an impact at a speed in excess of that associated with an emergency landing. The fracture surfaces exhibited characteristics that indicate the helicopter hit the water in forward flight with a left bank. The degree of bank could not be determined. No indications of pre-existing fractures were observed on the recovered wreckage.

The left landing gear had separated along with its pop-out floats. The pop-out floats on the right skid were found deployed when the wreckage was recovered, and were keeping the wreckage afloat. There was insufficient wreckage recovered to rule out the possibility of a mechanical anomaly which could have triggered a caution light and an emergency landing. The fuel tank was recovered intact and was partially full. A fuel sample was sent for laboratory analysis and no anomalies were detected.

No indications of pre-existing fractures were observed on the recovered wreckage. The damage to the main rotor mast and transmission indicates the rotor drive train was rotating at the time of impact; the rate of rotation could not be determined. Fuel exhaustion and fuel quality were not considered contributing factors.

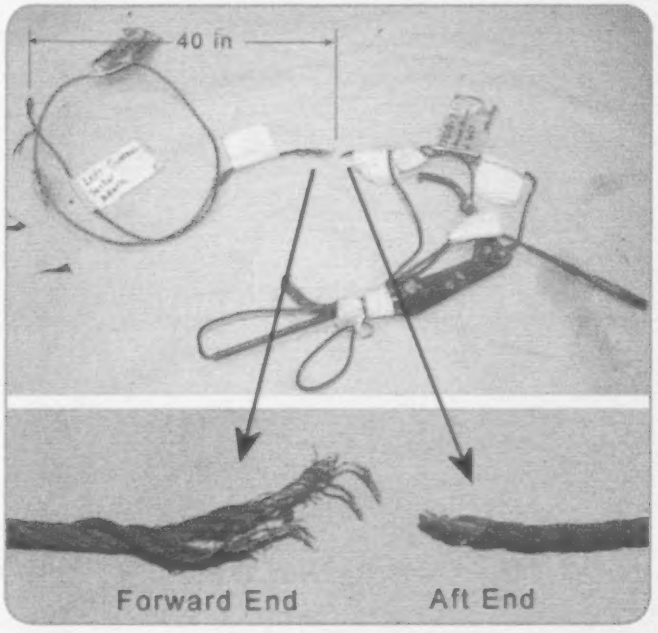
The investigation could not identify a reason why the aircraft rolled to the left after takeoff. Consequently, a number of hypotheses were considered by the investigating team and are discussed in details in the analysis section of the final report at the link above. The list of hypotheses includes the following areas:

Fractured left forward aileron drive cable assembly, as received at TSB Laboratory

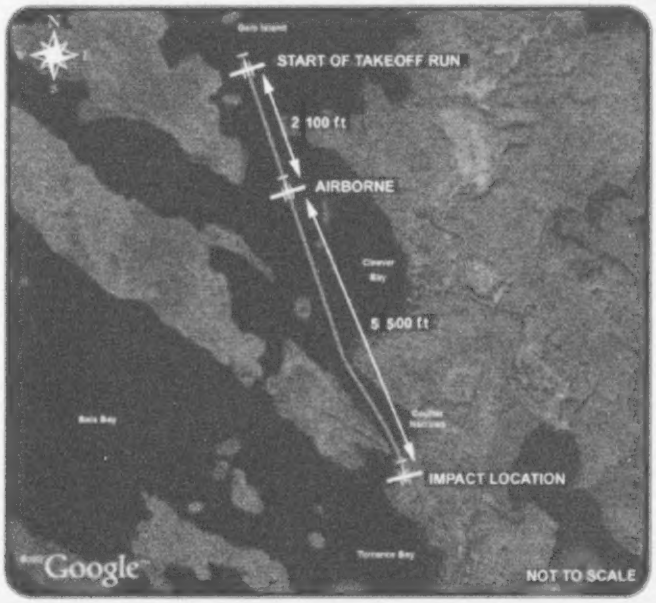
Estimated flight path

The aircraft appeared to be properly configured for flight as per the recommended procedures in the Pilot Operating Handbook (POH). There was no evidence found related to a flight control problem that might have prevented the pilot from avoiding a collision with the trees. The aircraft was airborne approximately 5 500 ft before the shoreline, a distance that is within its performance capability to continue a climb that would have avoided the tree impact. The investigation revealed no evidence that either an internal or external distraction diverted the pilot's attention away from controlling the aircraft. It is possible that the pilot, with limited flight time in this aircraft during the past two years, misjudged the height of the trees along the shoreline. If the aircraft had developed a mechanical abnormality shortly after lift-off that would have affected its climb performance, the pilot would have had sufficient lake surface remaining to land the aircraft.

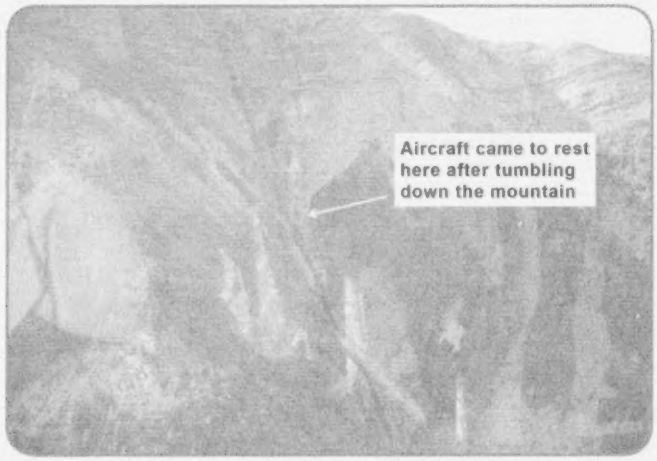
Note: *canopy reflexions in bottom half of photo were not photoshopped to preserve integrity of photo. RCMP Photo.*

The aircraft's structural integrity was completely lost as it tumbled down the slope, with failure of the occupant retention systems.

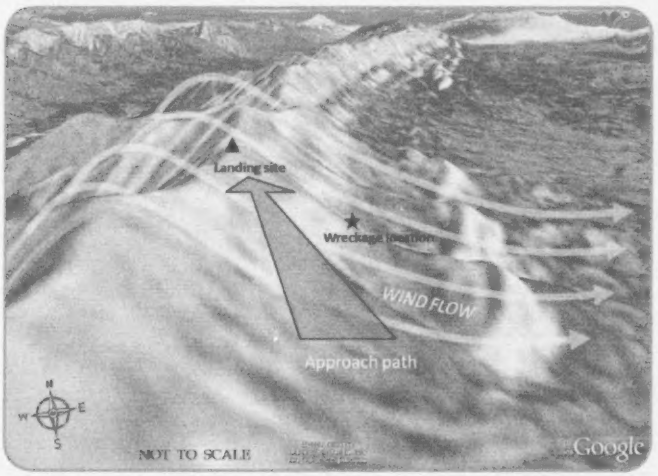
Flight path and wind flow

With deteriorating rotor speed and aircraft controllability nearing the landing zone, the pilot was faced with three choices: overshooting straight ahead, landing hard on uneven terrain on the ridge top, or turning around and attempting to dive down the steep slope. The option of continuing straight ahead into wind posed a risk of injuring the ground party near the landing zone either by striking them on the overshoot or by subjecting them to injury from the helicopter had it rolled over on uneven terrain on the ridge top. Diving off the ridge may have afforded space to allow a reduction of main rotor pitch and a recovery of rotor speed. However, placing the helicopter downwind with deteriorating rotor speed precluded maintaining sufficient height above the ridge to avoid striking the tail on the ground.

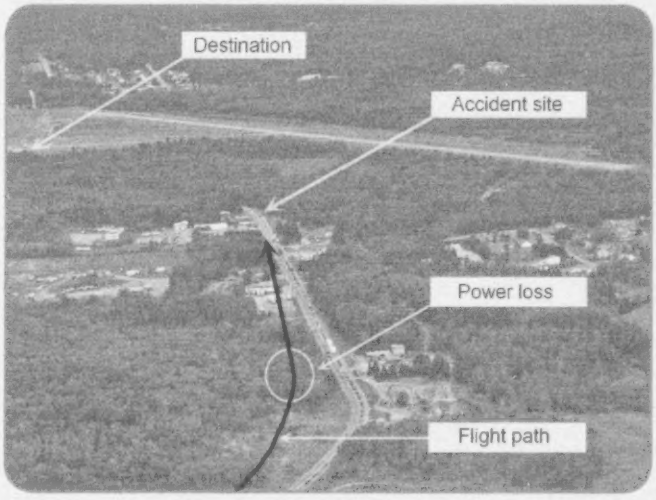
Return path to Mont-Laurier Airport

On the morning of August 5, 2009, a private Enstrom F-28C helicopter took off from Mont-Laurier Airport, Que., on a local VFR flight over the town of Mont-Laurier to provide a television cameraman with a bird's-eye of damage caused by a tornado. About 20 minutes later, as the helicopter was returning to the airport, the engine (Avco Lycoming HIO-360) experienced a power loss and backfiring. During an attempted emergency landing, the aircraft struck cables over Highway 117, struck the highway and rolled over in a ditch. The helicopter was completely destroyed in the post-impact fire. Both occupants were fatally injured.

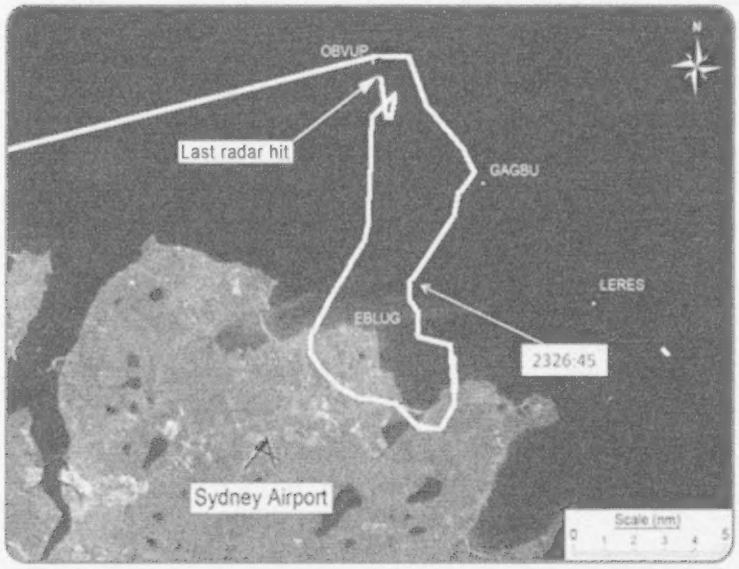
Aircraft flight path

The aircraft track nearing OBVUP created a sharp closing angle on the OBVUP-GAGBU track. As the aircraft neared the OBVUP waypoint, the course track bar on the GPS would have moved very quickly toward the GAGBU waypoint. Due to the maximum rate of turn that an autopilot system allows, the aircraft would have flown through the OBVUP-GAGBU track before regaining course. To prevent

this, a pilot would have to manually take control and initiate a steep turn. In an attempt to intercept the OBVUP-GAGBU course, an inexperienced pilot may try to follow the track bar using an increasingly steep bank angle. If this steep bank angle is left uncorrected, a spiral dive will result.

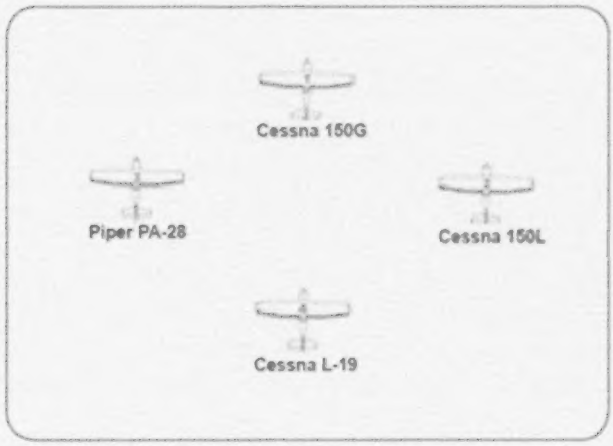
Figure 1

Earlier that afternoon, a local group of four pilots and two crew members decided to carry out a short flight to practise formation flying in the Mission-Chilliwack area. The group comprised a Cessna 150G, a Cessna 150L, a Cessna 305A (L-19), and a Piper PA-28-180. The group assembled for a formation flight pre-flight briefing at the Langley Regional Airport, where all four aircraft were regularly based. As discussed at the meeting, the round-trip flight was a daylight recreation VFR flight to the Chilliwack Municipal Airport. Originally, the leader had planned to fly to, and land at, a popular site near Harrison Mills, B.C., and then conduct a debriefing on the ground. However, following a discussion about the remaining daylight, the leader chose to fly to Chilliwack instead. The pilots' intentions were to practise simple formation flying en route, during which they would carry out basic station-keeping (maintaining position) with simple turning manoeuvres, in a loose diamond pattern (Figure 1).

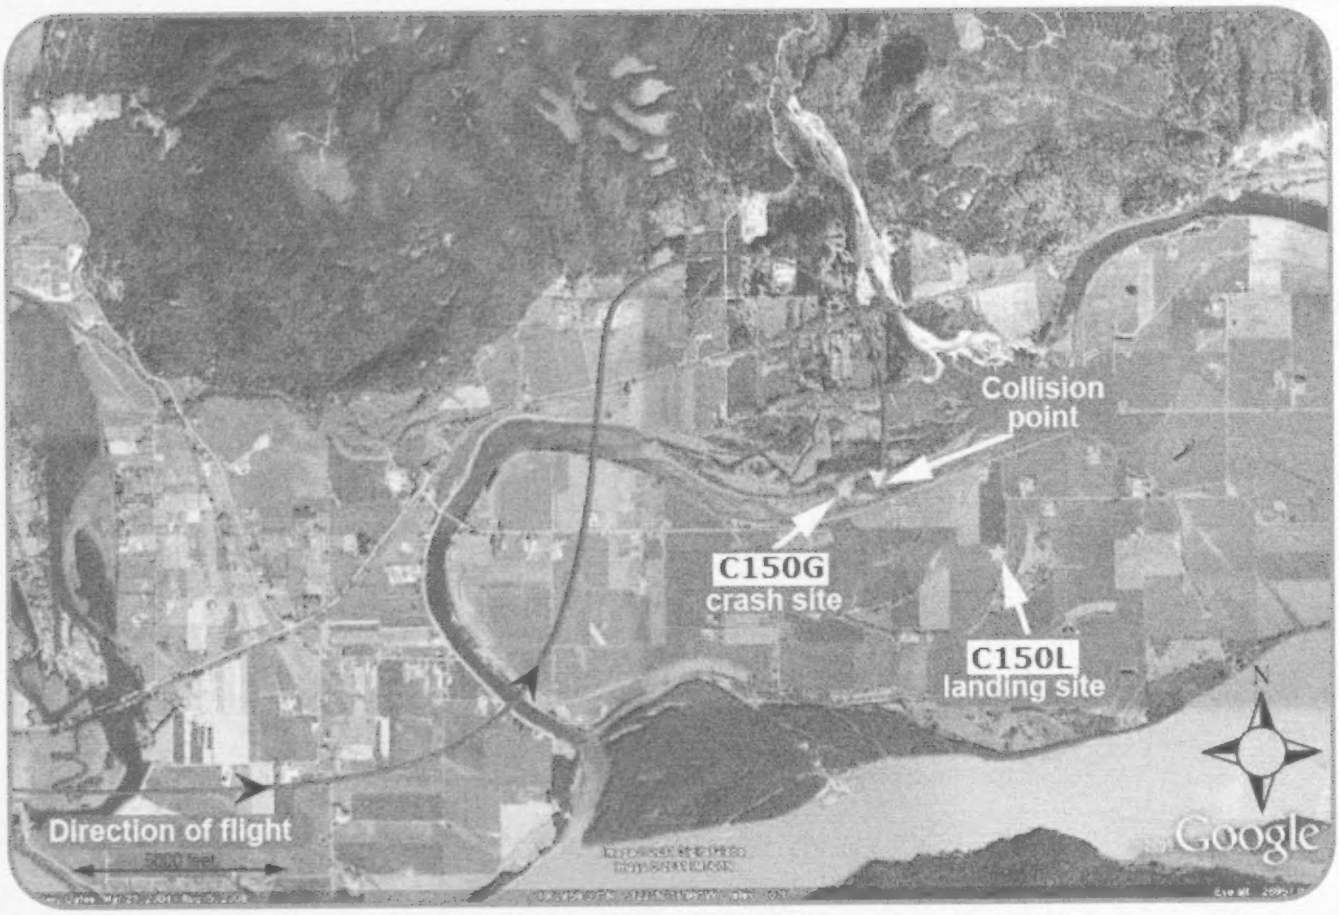
Figure 2. Site map showing route of formation flight

When the formation flight neared the township of Dewdney, B.C., at 1 500 ft ASL, about 1 450 ft AGL, and at a speed of 90 mph, the leader initiated a 15° angle-of-bank left turn for about a 90° heading change, and rolled out heading north. In preparation for this turn, the leader advised the number 2 aircraft (the C150L, on the outside of the turn) to increase engine power to account for the increased radius of turn. This instruction is in accordance with conventional station-keeping practice during formation flight, and was a practice this leader had often used with newcomers to the group. During this left-turn manoeuvring, the lateral distance and step-back of the number 2 aircraft on the leader's right side increased somewhat, but the C150L returned to its original position once the flight rolled out on the northerly heading (Figure 2).

During the turn, the pilot of the number 2 aircraft (the C150L) lost sight of the lead aircraft (the C150G), turned away to the right and descended. After a brief interval, the C150L turned left and climbed while the pilot searched for the leader to rejoin the formation above.

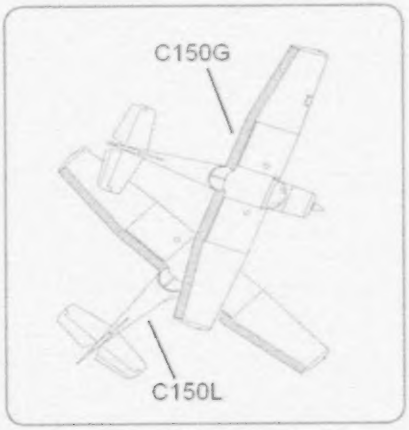
Figure 3. Collision diagram

At 1615, seconds after the leader called a roll-out, the two aircraft collided at almost 70° to each other (Figure 3). The aircraft began to rotate and descend joined together, and fell out of control for several seconds. At about 400 ft AGL, the aircraft separated; the C150G broke up in flight and fell into a shallow slough, while the pilot of the C150L regained control and landed the aircraft without engine power in a farm field.

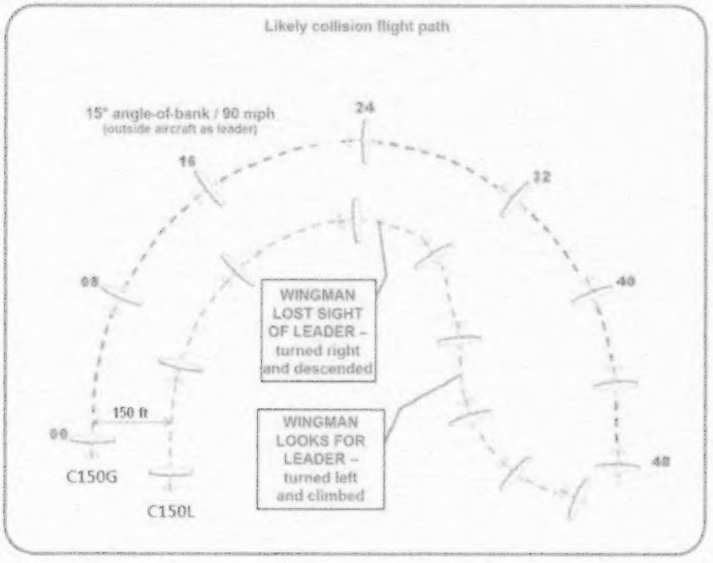
Figure 4. Likely collision flight path (diagram not to scale)

In summary, the Laboratory analysis concluded that, during the entry to the right turn (Figure 4), the speed differential would have caused the C150L to overtake and lose sight of the leader. This would also have prevented the pilot of the C150L from seeing the leader during the last left turn before the collision. It was also concluded that the leader would have been unable to see the wingman aircraft approaching from the right side until it was too late to avoid contact.
